# Diversion Dynamics: A Process-Based Approach to Deconstruction Analysis

**THE SNYDER EQUINE RESEARCH FACILITY AS A CASE STUDY**

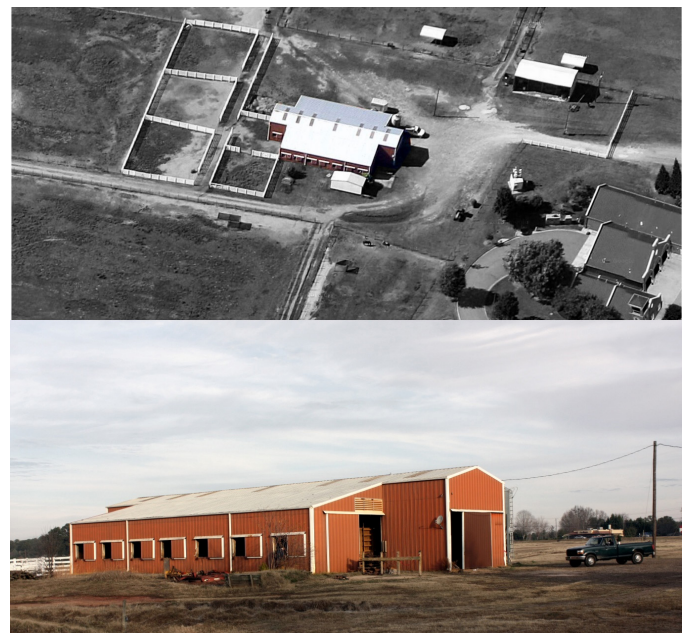
Figure 2: The Snyder facility: Aerial view and view from the south

facility was constructed more than a decade later, in 2015. The university’s Material Reuse Program was charged with deconstructing, reselling and reusing the Snyder facility components. The deconstruction process took place in two phases. The first phase included removing around 20 acres of vinyl fencing west of the facility structures. The second phase, which is the subject of this case study, included the full deconstruction of the facility’s main structure. The primary structure consisted of a light timber-frame assembly, clad by a thin layer of Styrofoam and painted aluminum exterior siding.

The building had a number of ideal attributes for high quality material recovery: First, since most of the spaces were designed primarily for livestock, there was very little flooring. This made access to subterranean components such as foundations and sewage systems easy, clean, and quick. Secondly, almost all of the materials used were untreated and uncoated, making many of the components excellent candidates for recycling. The painted aluminum siding was the only major component to contain coating, although there are well developed technologies for full recycling of painted aluminum<sup>3</sup>. Thirdly, many of the more complex components in the building such as the main roof trusses and all of the

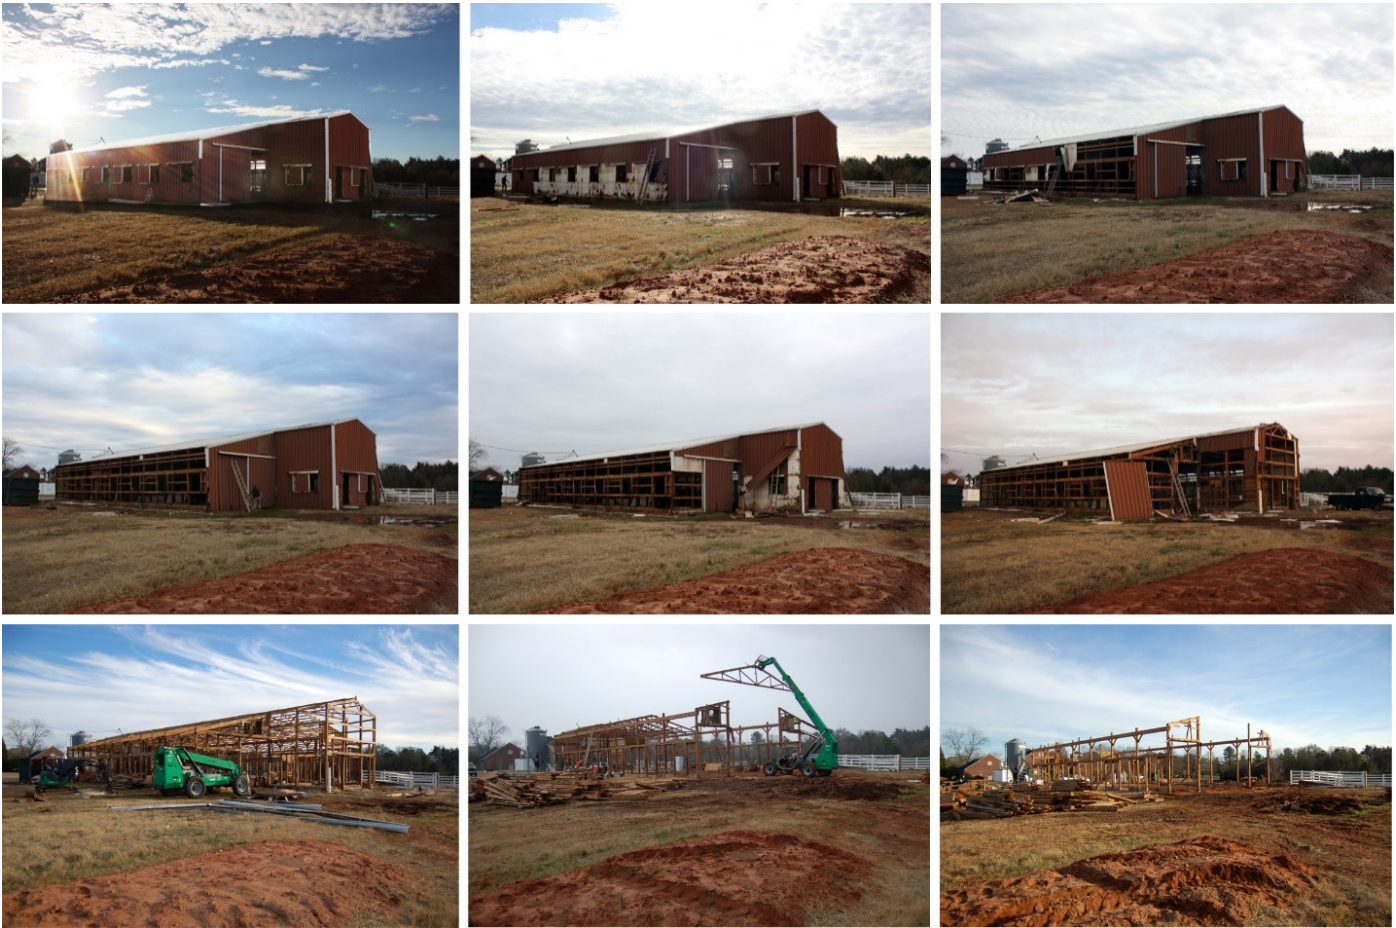
Figure 5: Selected time-lapse photos illustrating different stages in the deconstruction sequence: View from the north

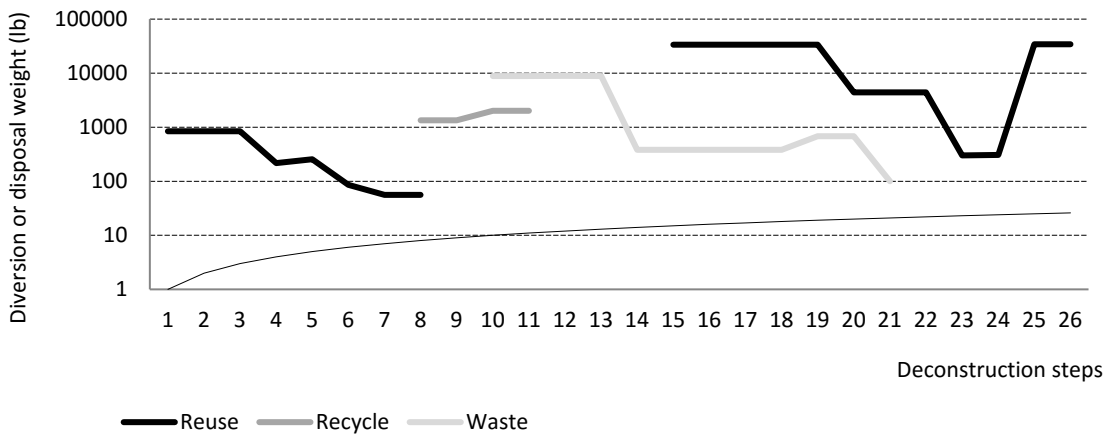
Table 3: Diversion rate variation based on stream type and deconstruction step.

Table 3 indicates that: A) the removal of components designated for recycling concentrates in a relatively small number of steps during the early stages of the deconstruction process. All recycling-bound components were removed between steps 8 and 11, which included the building’s roof and wall siding. B) Most of the landfill waste was generated between steps 10 and 13, which included all the envelope insulation foam and the GFRP skylight panels. C) While components for reuse were retrieved throughout both the early and late stages of the deconstruction process, most reuse content by weight was generated during the disassembly of the timber structure (steps 14 to 20) and during the excavation of the concrete footings (step 25 to 26).

*C. Technological challenges:* Recycling rates in a deconstruction project depend to a large extent on the availability of appropriate recycling technologies. As can be seen in table 3 and table 4, there is a clear correlation between the content designated for recycling in the Snyder project to a single material group: metals. Although it may be motivated by an interest in maximizing reuse rates in the project, the exclusive recycling of metals may also be a result of lack of adjacent recycling facilities for other material groups such as timber and concrete. A process oriented approach can identify such challenges early in the process aid in comprising a comprehensive material recovery management plan.

*D. Sequence challenges:* As table 3 suggests, most of the components retrieved for reuse purposes were salvaged from the building relatively late in the deconstruction sequence. During the first 10 days or so of the process, the vast majority of materials removed from the building were recycled or discarded. Typically, one would expect a reverse order of diversion quality: Delicately removing components for reuse while the site is clean and the deconstruction crew is focused followed by removal of components for recycling and eventually disposing of components unfit for recovery. Although much of the sequence is typically predetermined by early design decisions, a process oriented approach to deconstruction planning can assist in finding an optimal recovery solution for a given set of circumstances.

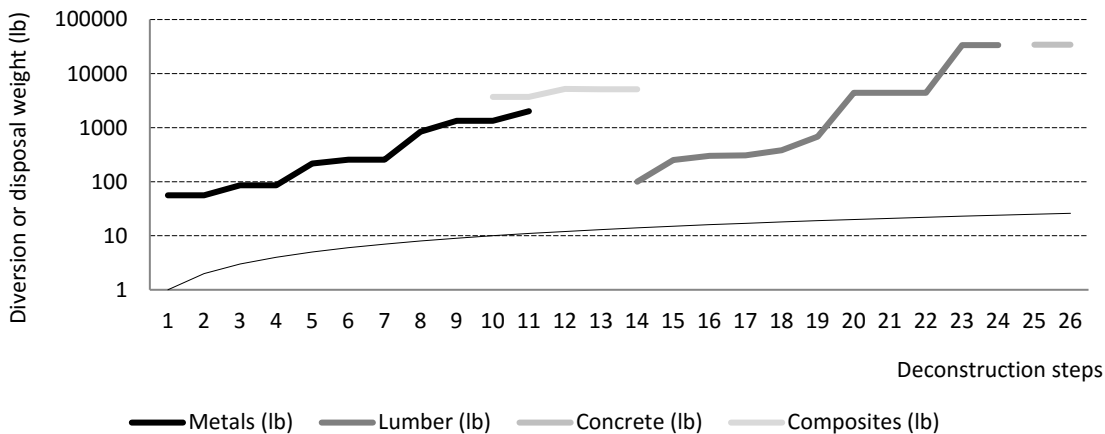
Table 4: Diversion rate variation based on material group and deconstruction step.

Table 4 indicates that: A) there is a clear correlation between material groups and the distribution of stream types described in table 3. Metals correspond with reuse and recycling streams, composites correspond with waste streams, lumber corresponds with both reuse and waste,

and concrete footings correspond in this project with reuse. B) There is also a clear correlation between material groups and the chronology of deconstruction. Metals were removed early in the process, followed by composites, lumber and finally concrete. This is mainly due to the roles these materials groups played in the structure of the Snyder facility: Metals made up much of the skin, lumber made up both the envelope structure and the primary structure, composites made up the insulation, and concrete made up the foundations.

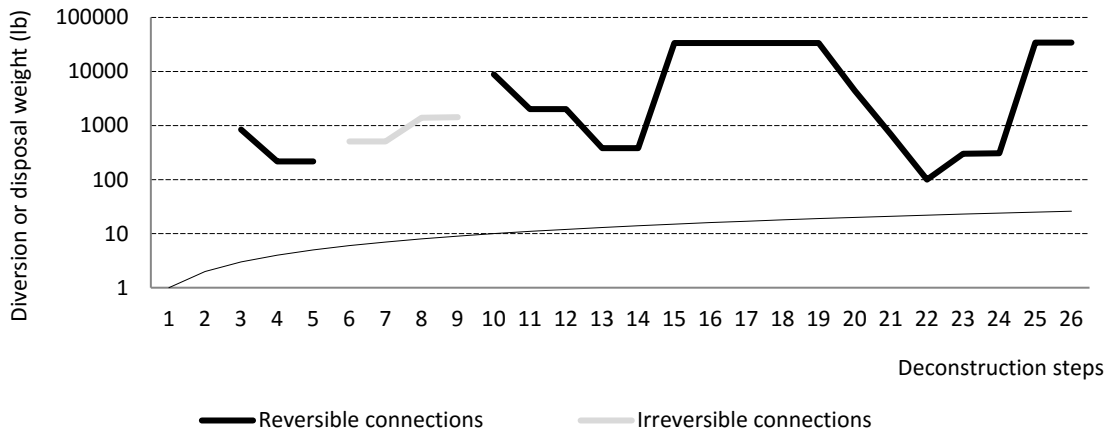
Table 5: Diversion rate variation based on connection reversibility and deconstruction step.

Table 5 indicates that most of the components in the building, both by weight and by deconstruction sequence steps, are characterized by some degree of connection reversibility, a fact which undoubtedly assisted in achieving high recovery rates. It should be noted, however, that although only a small number of deconstruction steps are associated with irreversible connections, they refer to a major part of the building: its entire external wall siding.

*E. Connection type challenges:* Although, as table 5 shows, only a small number of deconstruction operations had to negotiate irreversible connections, those operations took much longer than expected and resulted in considerable damage to the materials salvaged. While it is difficult to avoid the challenges presented by detaching large portions of heavily nailed surfaces, the use of a process oriented evaluation can aid in reaching a more realistic time estimate for these specific steps in a deconstruction sequence.

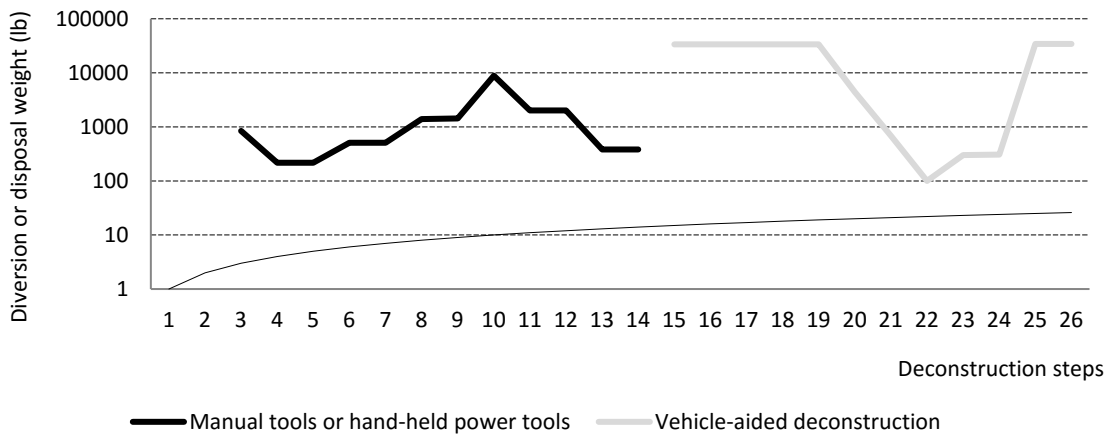
Table 6: Diversion rate variation based on tool category and deconstruction step.

Table 6 indicates that the introduction of vehicle and machine-aided deconstruction operations around step 15 help yield larger amounts of recovered materials from that point on until the final steps of the process. Clearly, this specific depiction is influenced in part by the use of weight as a diversion metric. A use of market value instead, for example, might result in a different interpretation.

*F. Tool and access-related challenges:* As can be observed in table 6, tool type, component location within the structure, and its handling dimensions played a key role in the amount and speed of material recovery in the project. While simple manual tools provided flexibility and ease of access in the early stages of the deconstruction process, they were also significantly slower in unfastening mechanical or fixed connections.
