The Best Laid Plans...

MARY C. HARDIN

The University of Arizona

A SCORIA HOUSE

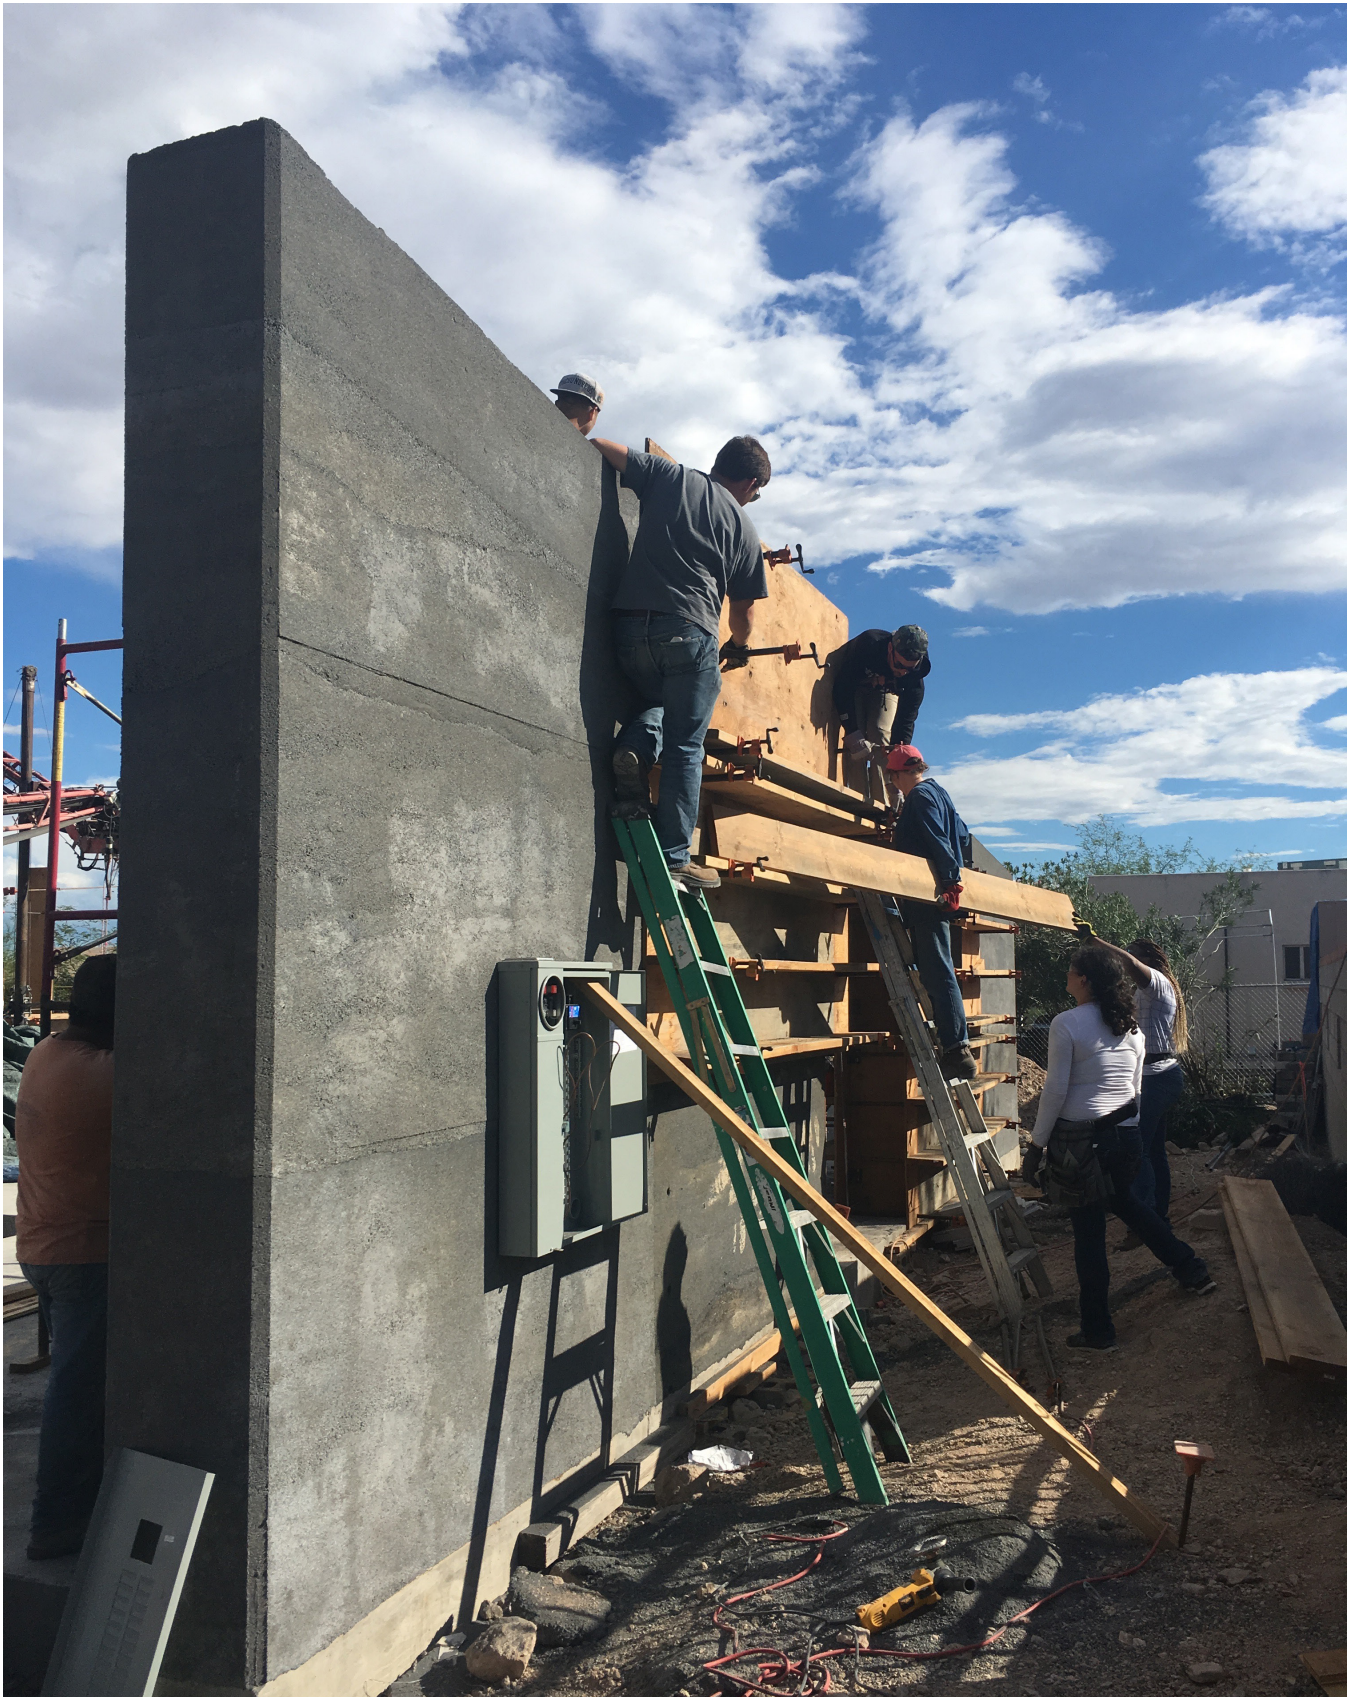
Figure 1. Students constructing scoria walls. Photo by author.

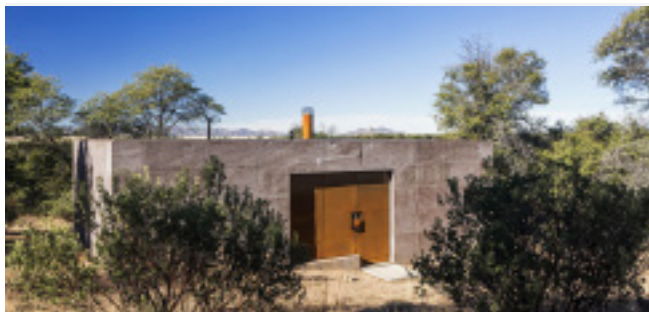
Figure 2. Pumice stone used in Casa Caldera by DUST Architects. Photo @ Jeff Goldberg/Esto .

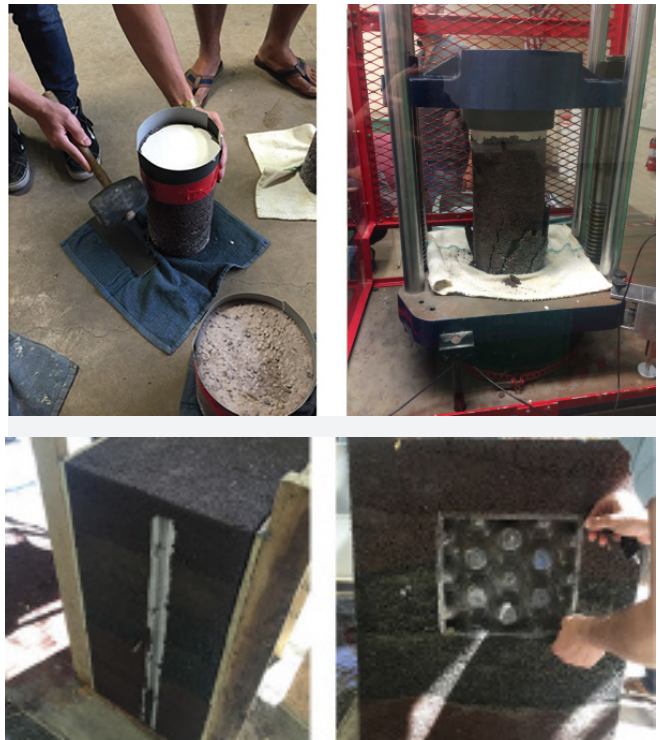
Figure 3. Cylinder tests and wall mockups. Photos by author..

mining businesses. Because the known precedents neither prescribed a “recipe” for scoria mixtures nor articulated any performance criteria, a semester of research determined how scoria might be classified in the local code amendments and identified performance metrics⁶. Students prepared cylinders of varying mixtures for compression tests to establish a reliable blend for fieldwork and built full-scale mockups of the construction conditions. While these investigations progressed, students designed a dwelling with long scoria walls facing east and west. The hypothesis was: those exposures receive direct sun for only a few hours daily, thus allowing the 18” thick walls to serve as thermal flywheels, cycling heat back outside as the exterior temperatures cooled off at night.

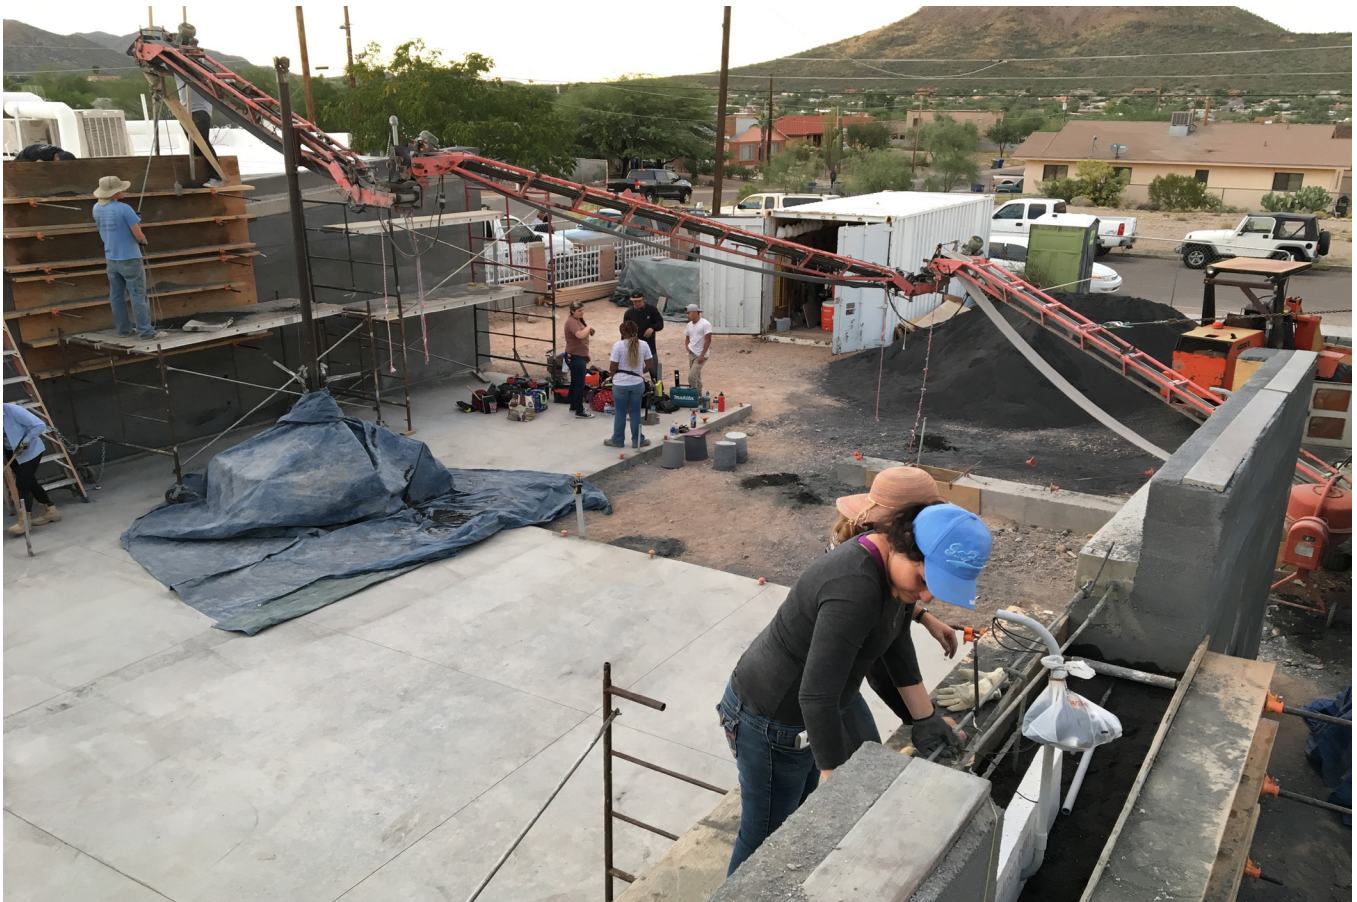
Figure 6. Students construct scoria walls. Photo by Queston Kwolek.

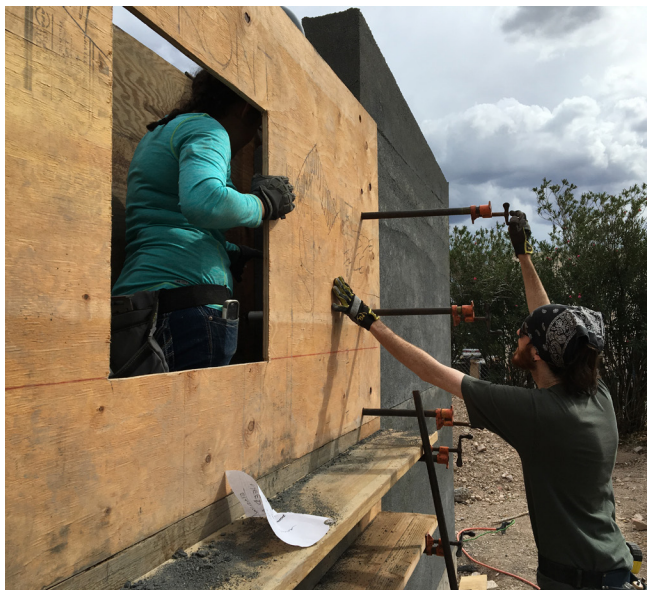
Figure 7. Formwork for window box. Photo by Queston Kwolek.

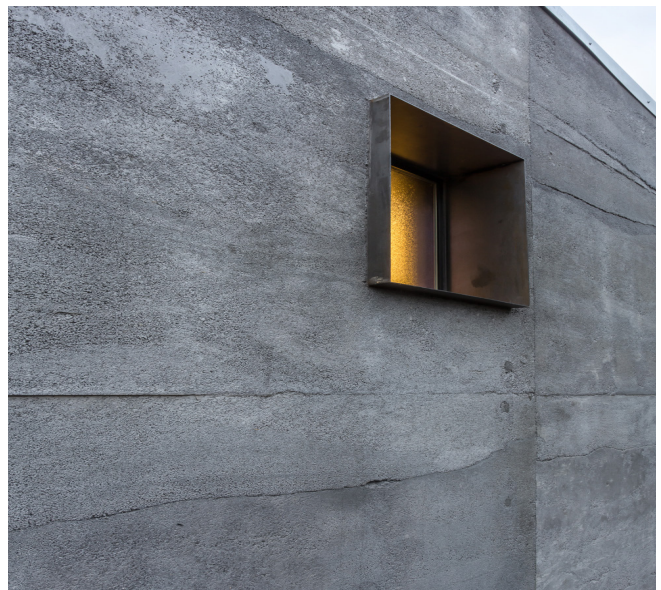
Figure 8. Completed window insert. Photo by Velen Chan..

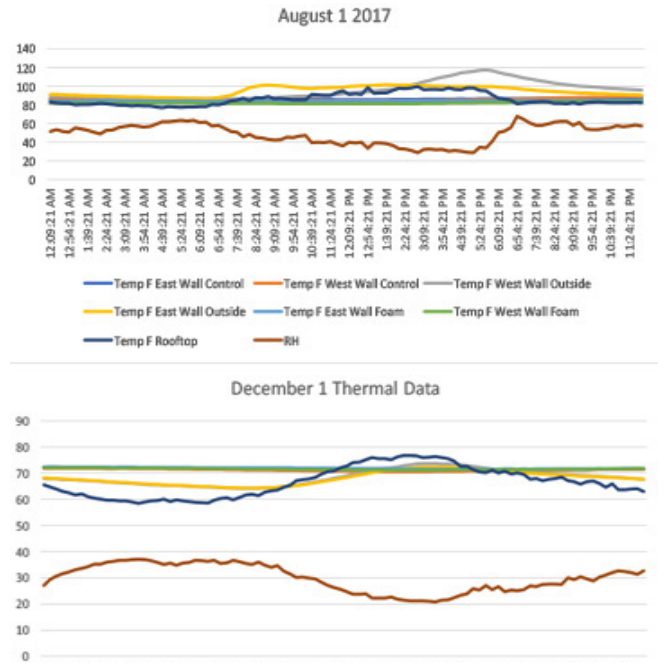
Figure 10. Thermal sensors and data. Images by author..

Thirty days of sensor readings validated performance and the house was approved for occupancy. Eleven subsequent months of data substantiated that the “breathing” dwelling was indeed functioning within the human comfort zone. All project data was entered by the building official into the public record of the municipal Development Services permitted project data base, ensuring its availability as precedent for future plan reviews and code inspection decisions regarding air infiltration through earthen walls and waivers of blower door tests. In this way, the materials research gained greater significance than the achievement of a single project; it paved the way for future experimentation with thermal mass wall materials. This precedent is important for a region that has a long history of building with earthen wall materials without added layers of insulation; it is

9. During the desert summer with no air conditioning or ventilation, exterior surface temperatures ranged between 88° F and 130° F, but the interior scoria wall temperatures stayed stable at about 90° F.
